CONNECTOR HIGH CURRENT TEST

Test the current carrying capability of some popular connectors used in FRC.

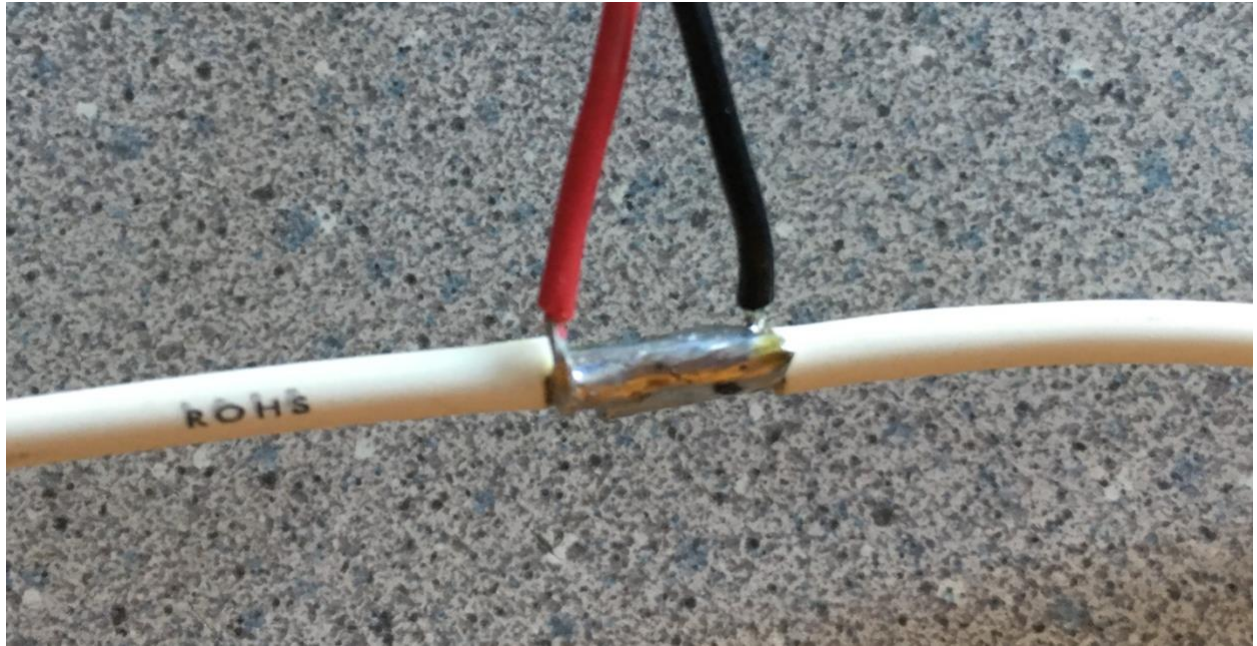
The connectors were wired in series using the 12ga wire and connected to the terminal of the current source. Kelvin connected wires were installed across each of the connections to measure the voltage drop generated by the current flow. The Kelvin leads were connected to the DAQ (fig 1 - 7).

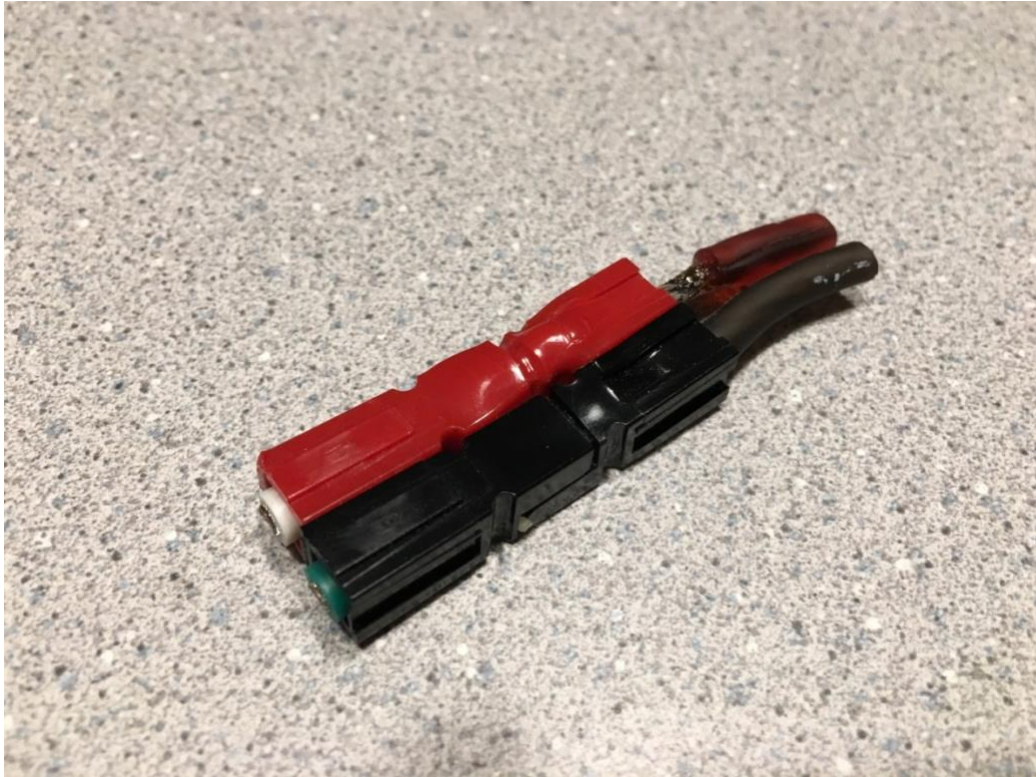
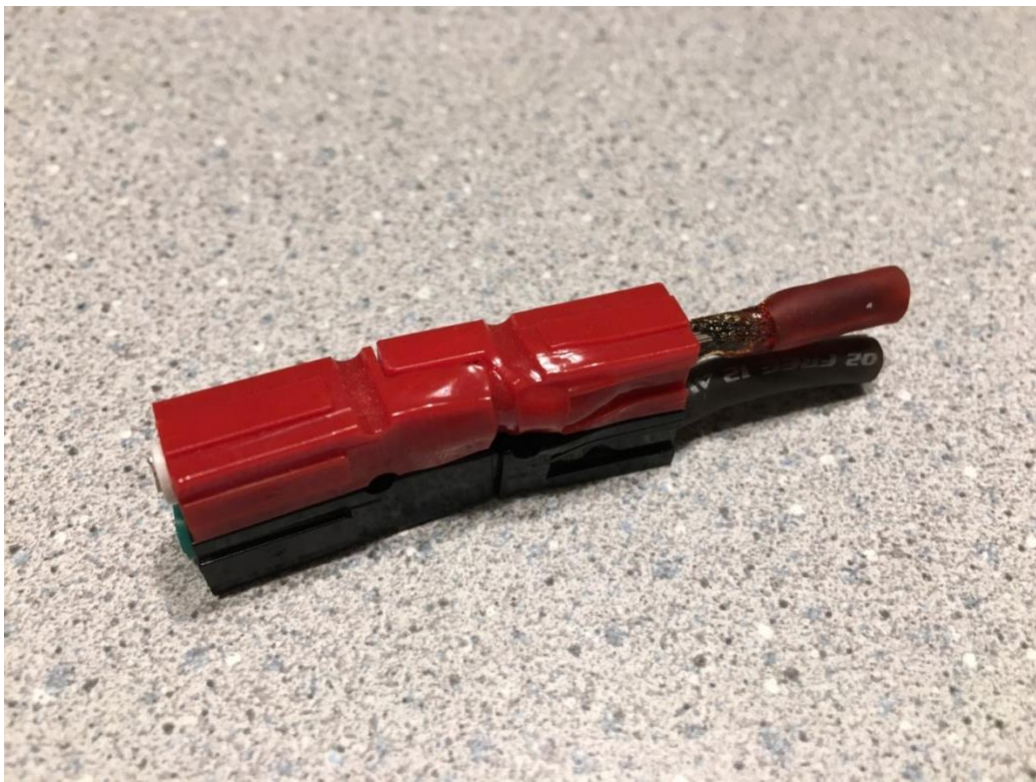
Poorly assembled connectors can lead to a high resistance joint which can result in overheating of the connector or failure over time from movement or vibration. An example of poorly assembled Anderson style that had approximately 25 Amps continuous for 5 minutes (fig. 10 - 11).

From observing the location of the heat damage, it appears this failure was caused by a poor crimp on the red wire.

There are two common problems with the Anderson style connector. One is the pin being incorrectly installed in the housing. Typically this is caused by pin deformation from an incorrect or improperly used crimp tool. The other is the crimp quality caused from an incorrect or improperly used crimp tool

Inspect the pin after crimping to verify that the crimp looks good and the pin isn't deformed. When the pin is inserted into the housing, verify that it locks into the housing as designed and there are no external forces pushing or moving the pin out of its designed location within the housing.
